Maine Corporate Wetland Restoration Program

Mill Cove on Spruce Creek, Kittery, ME

Findings of Preliminary Site Visit

December 21, 2007

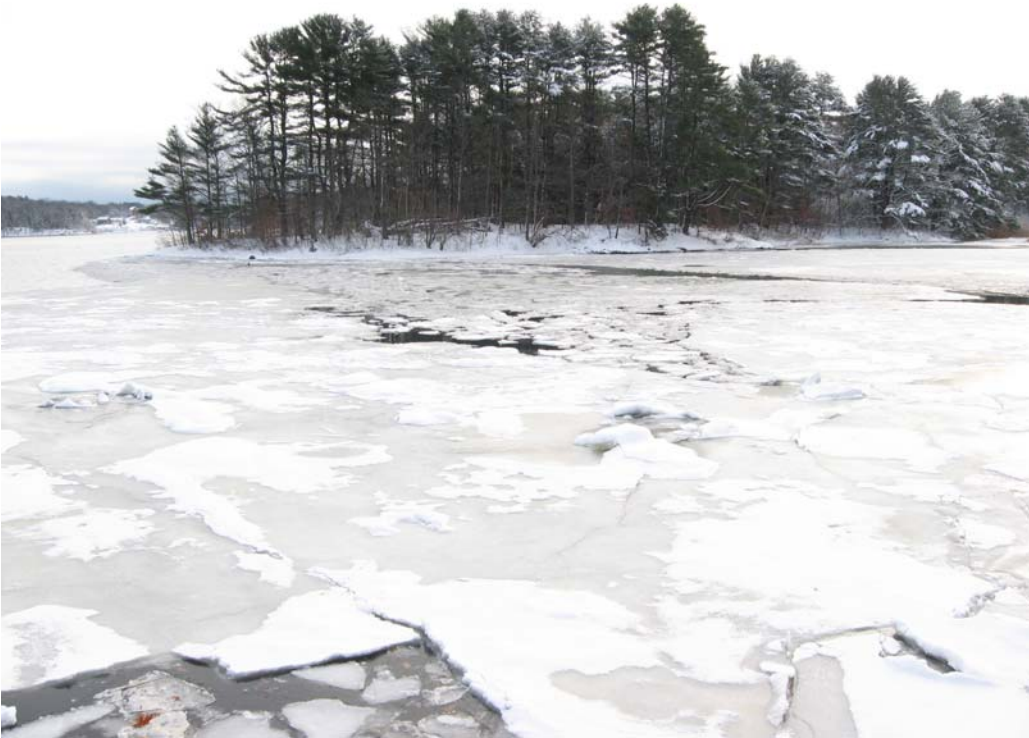
The dam was mostly obscured by ice and snow, but the top portion was visible as rock and rubble. Infilling behind the dam has raised substrates to approximately the level of the breach. Much of the bottom of the impoundment was exposed when the dam began impounding water.

Mill Cove dam near high tide (12/21/07)

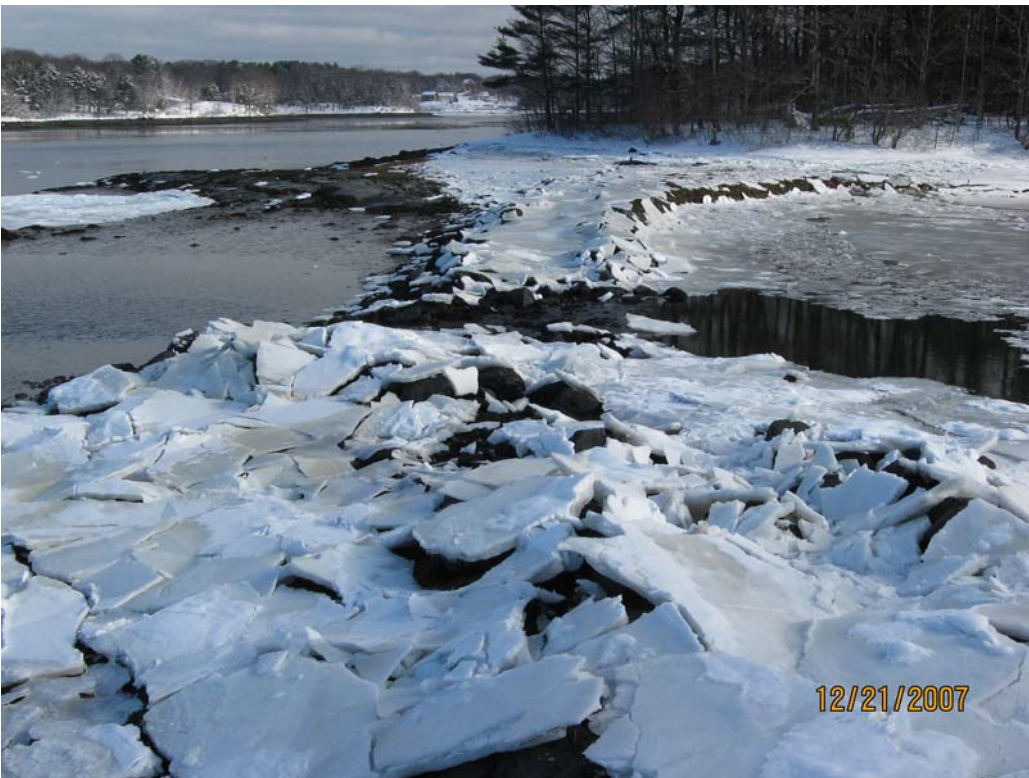
Based on our qualitative measurements, the following statements can be made. The top of the dam became visible approximately 3 feet below high tide, although flow did not appear to be restricted. The dam began impounding water at approximately 6 feet below high tide (1030). Five hours after estimated high tide, the water level in Spruce Creek was approximately 4 feet below the water level behind the dam. A reduced flow of water continued to drain out the breach in the dam throughout the time the tide was below the level of the dam. We left the site at 1300.

Dam on ebbing tide showing breach.

- Identify the impounding elevation and material (natural ledge or man-made dam)
 - If it is natural ledge the entire length of the dam, then dam removal will not increase drainage in the cove or improve fish passage at low tide

- If a man-made structure is impounding water, determine to what depth it extends relative to tidal range
 - Test substrates behind dam for toxic and hazardous content to evaluate the potential for dredge removal or flushing into Spruce Creek

- Explore with SHPO and Town the possibility of removing a portion of the dam to allow tidal flow, while preserving the remainder
- Examine historic aerial photos and maps to determine

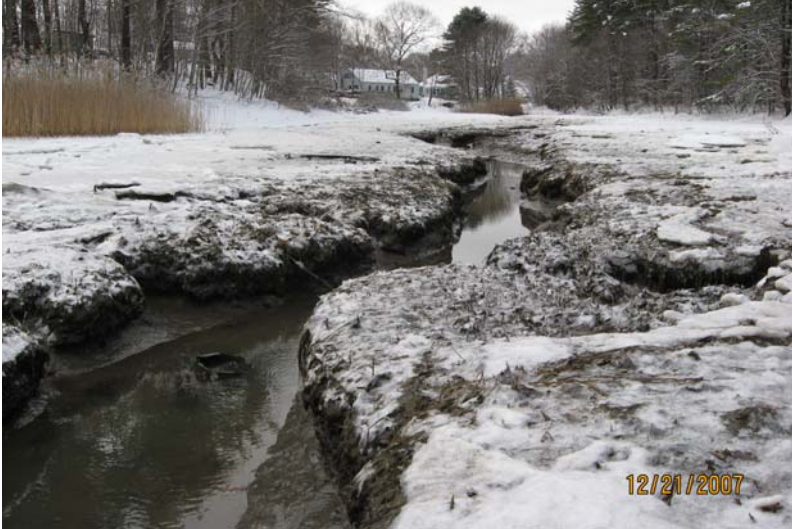
We walked the west side of Mill Pond Cove with John. Three small but well established stands of Phragmites (*Phragmites australis*) occurred along the east shore: two in close proximity to development in the upper cove, and one further downstream near Eagle Point. Other invasive species included Japanese knotweed (*Polygonum cuspidatum*) and multiflora rose (*Rosa multiflora*) on the upland edges of the marsh. Multiflora rose, barberry (*Berberis* sp) and buckthorn (*Rhamnus* sp) were present in a young forest/old field under conservation easement.

Southern lobe showing tidal creek and Phragmites.

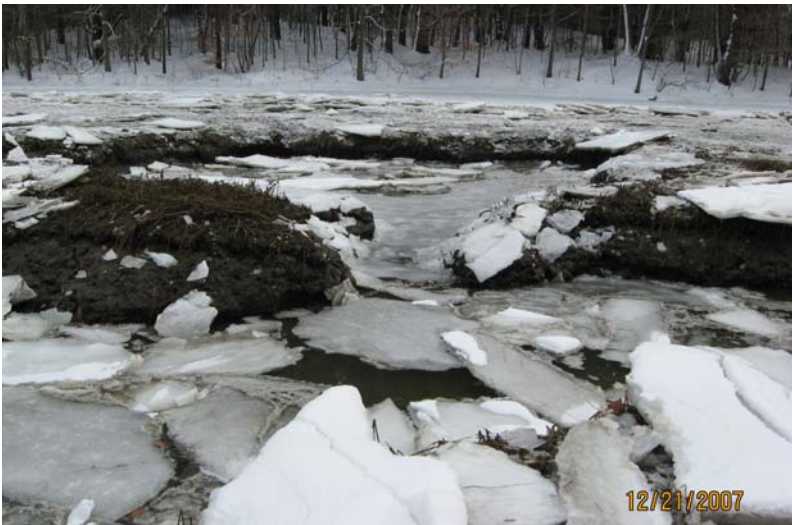
Pool in mid-marsh fully connected to main tidal channel.

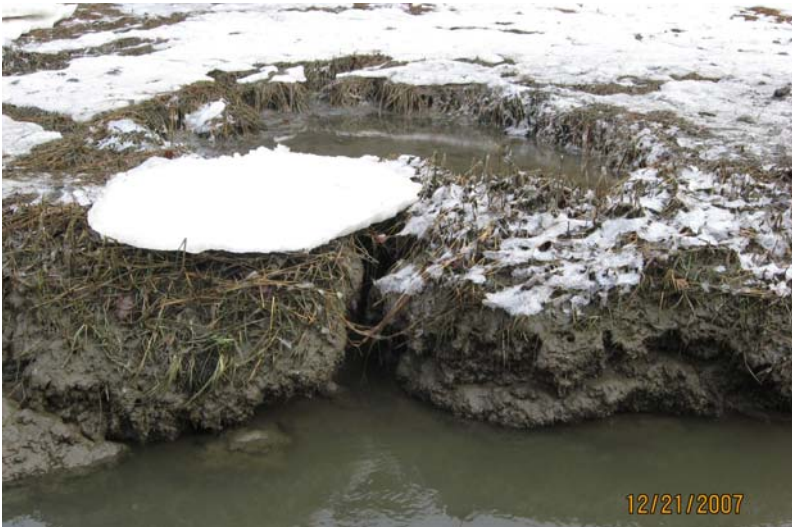
The salt marsh was well developed in the upper half of the marsh, predominantly low marsh with some high marsh in patches and near the upland. Much of the marsh was obscured with ice and snow. A narrower shelf of low marsh fringed the mill pond. In the mid-marsh section, where the tidal channel is still relatively wide, the marsh appears to be unstable and collapsing both along the edges of the channel and in several pools on the marsh surface. The pools appeared to be in various stages of development, with some deep, well incised and with open channels to the creek, while others were shallow with poorly defined edges and channels.

Pool in mid-marsh in process of forming and draining to main creek.
