RESTORATION SITE SUMMARY REPORT
Habitat Restoration Inventory

Site ID: SC-036

Waterbody: Spruce Creek

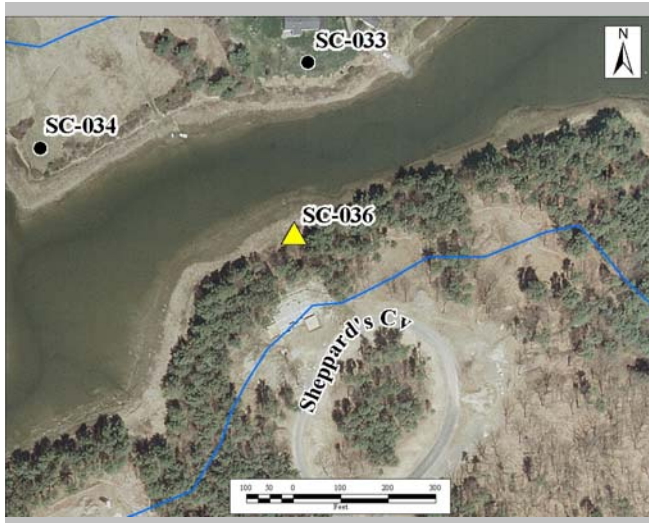
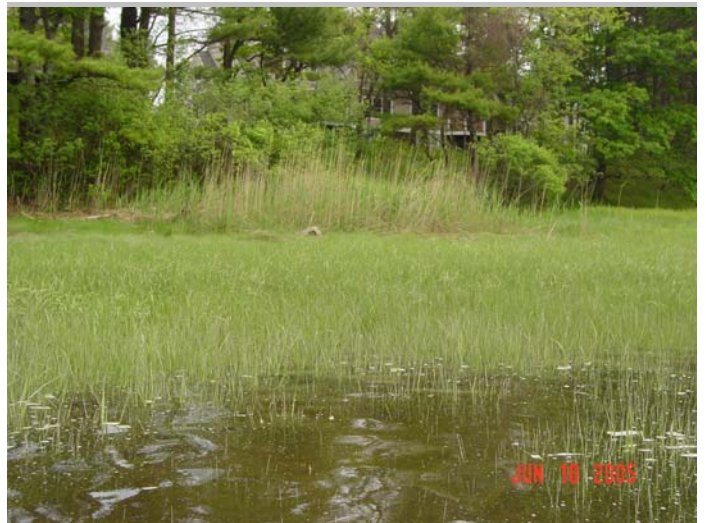
Phragmites stand, approximately 10 x 30 feet at the longest. Dead stems of last year persistent, new growth just coming up. Appears that new growth has less aerial coverage, but may be due to time of survey.

Sources of Degradation (13 possible): Invasive plant species

Spot-treat Phragmites with herbicide.
